# MARINE ENVIRONMENTAL ASSESSMENT OF A TRIAL SITE FOR A PROPOSED BLUE ECONOMY ZONE

prepared for  
Blue Economy CRC  
May 2024

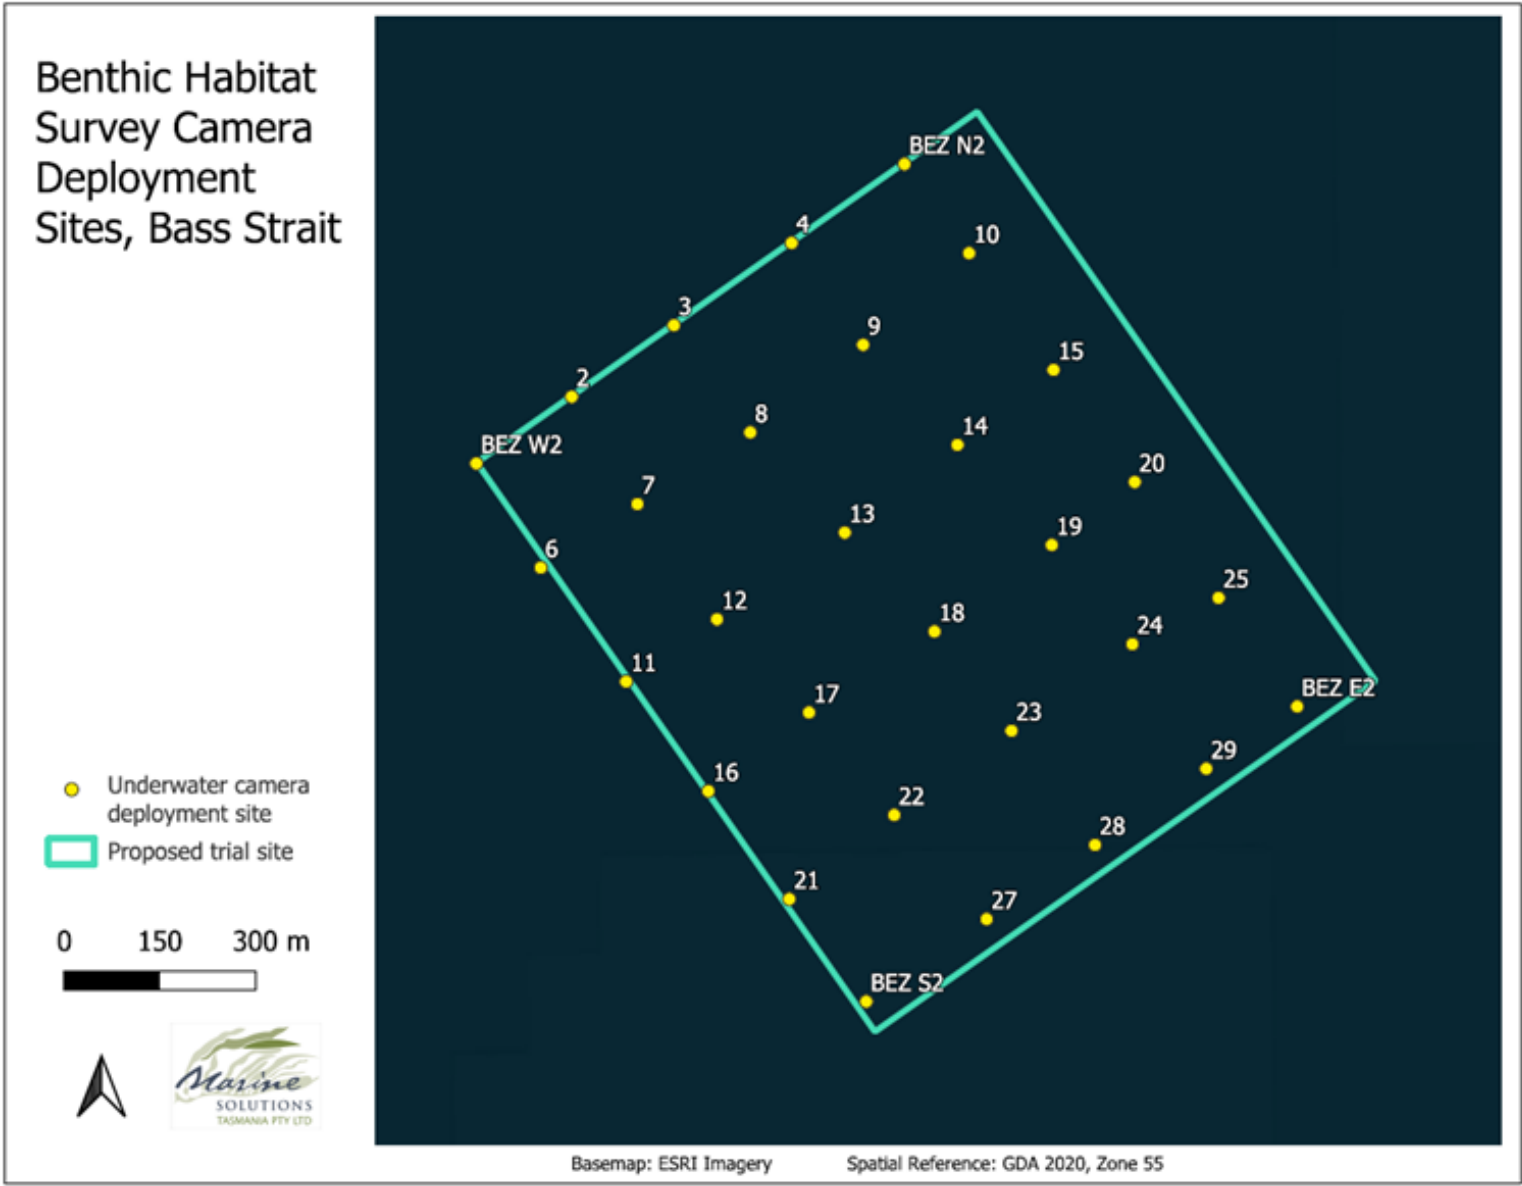
Figure 2. Benthic habitat survey camera deployment positions.

The starting position for each camera deployment is shown in Figure 2.

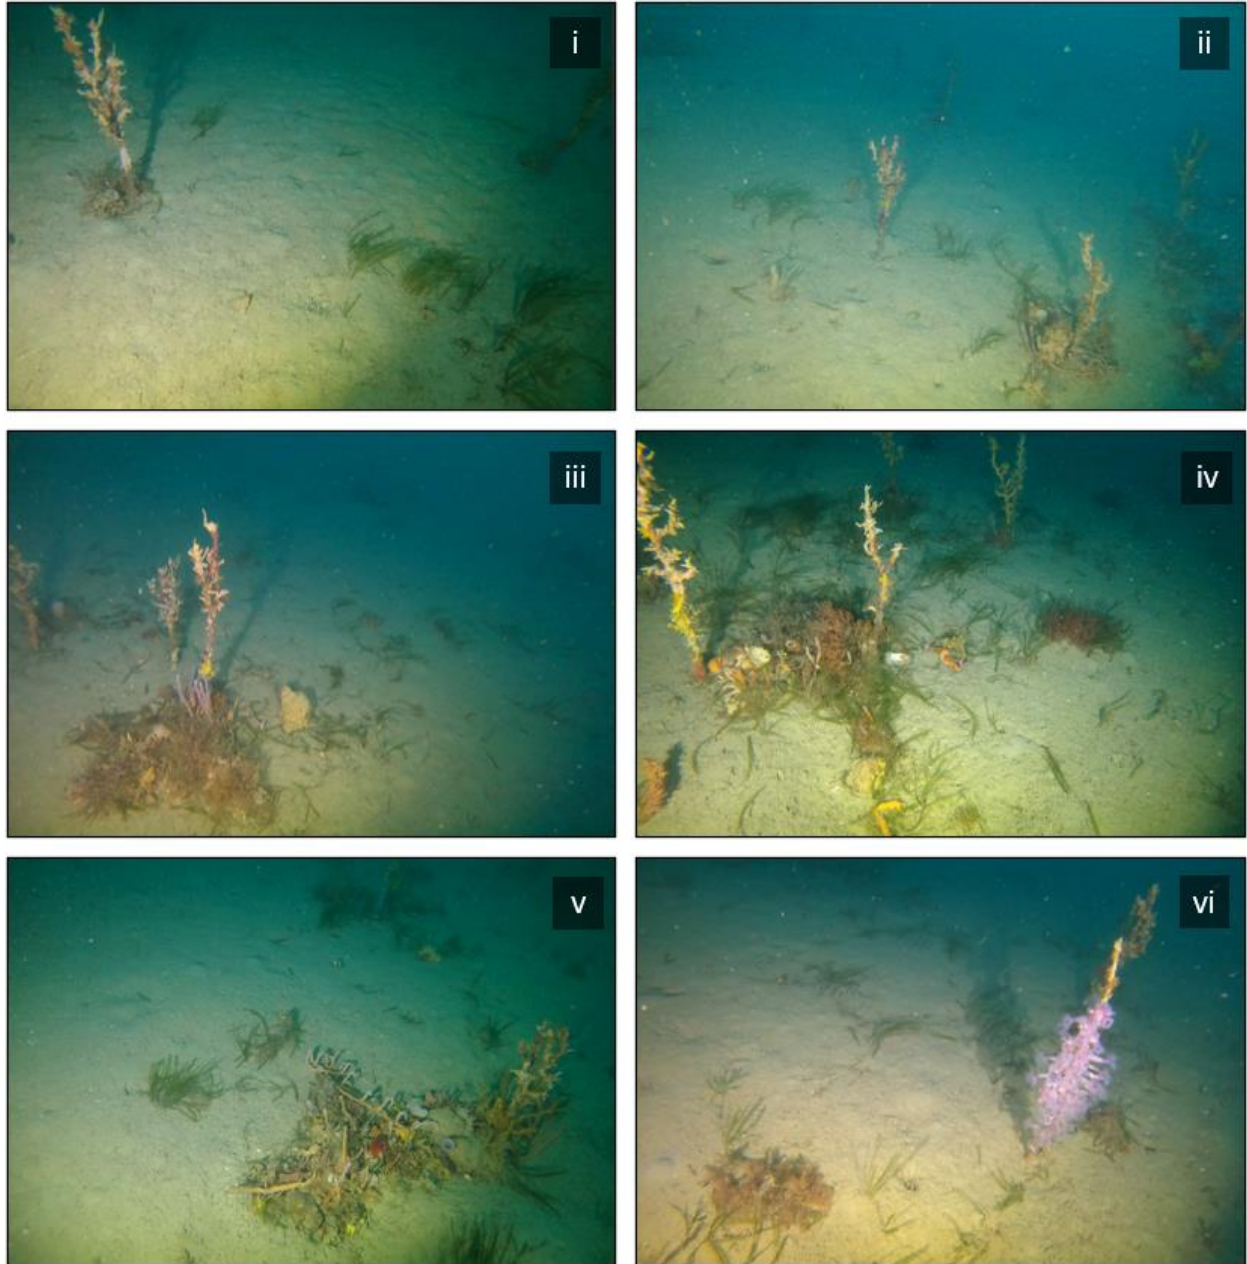
Figure 4. Example images of *Caulerpa* sp. densities. In addition to sponges and algae, species include ascidians (iv and v), and zoanthids (vi).

Sponges were observed at all 30 survey sites. Sponges were present in a variety of forms including branching, stalked, encrusting, cups, golf balls, tubular and laminar (Figure 3, Figure 4, Figure 5).

*Caulerpa* sp. observed was sparse and patchy (Figure 4).

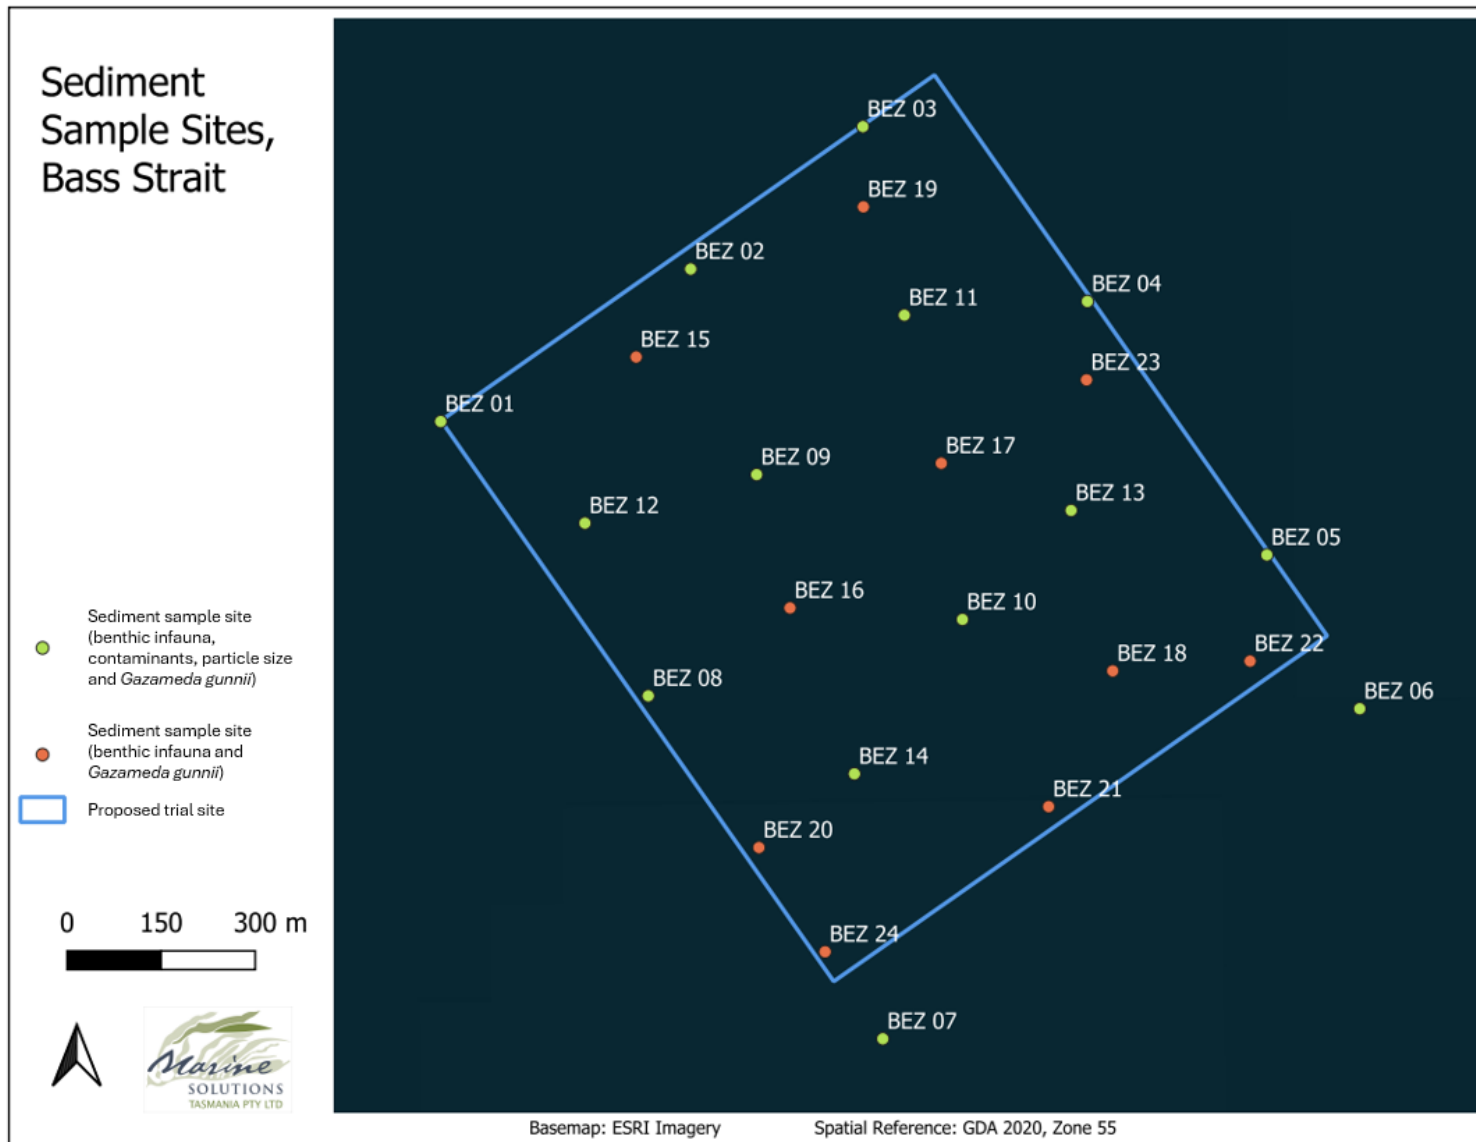
Figure 9. Sediment sampling sites within the BEZ trial site.

Sediment samples were collected from 24 sites within the survey area on 6<sup>th</sup> of February 2024 (Figure 9, Appendix 2). Sites were distributed haphazardly throughout the survey area.

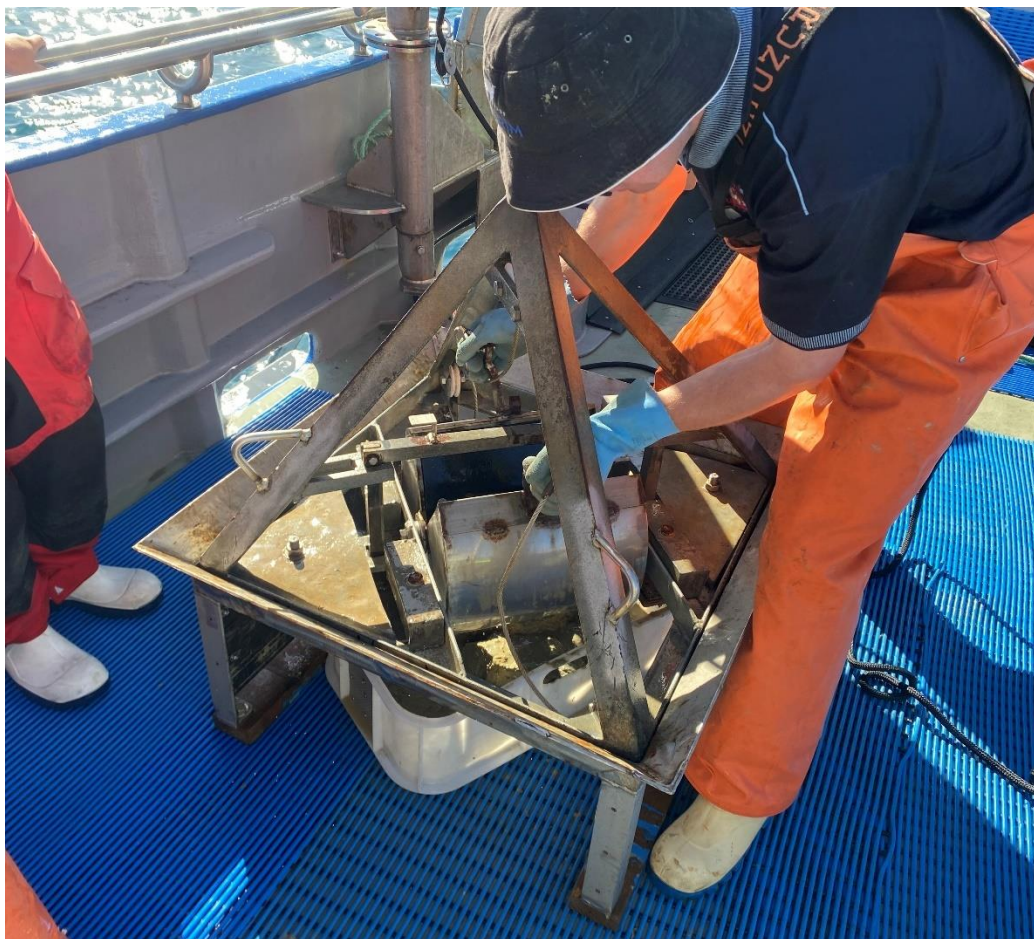
Figure 10. The Ponar grab operated from the winch on board the research vessel.

Samples were collected using a winch operated Ponar grab (Figure 10) and transferred to a prewashed and flushed intermediate holding vessel. Each sediment grab sample was labelled and photographed. All sediment samples were analysed for *in situ* detectable characteristics, including layering, colour, texture, and odour.
